**Trial to demonstrate the effectiveness of a
'PondTec 50' Ultrasonic Unit
in eliminating a bloom of blue-green algae
Oscillatoria sp
in
"The Match Canal"
Whitmore Fisheries
Nr Blackpool
Lancashire**

September 2010

Sustainable Soil & Water Ltd

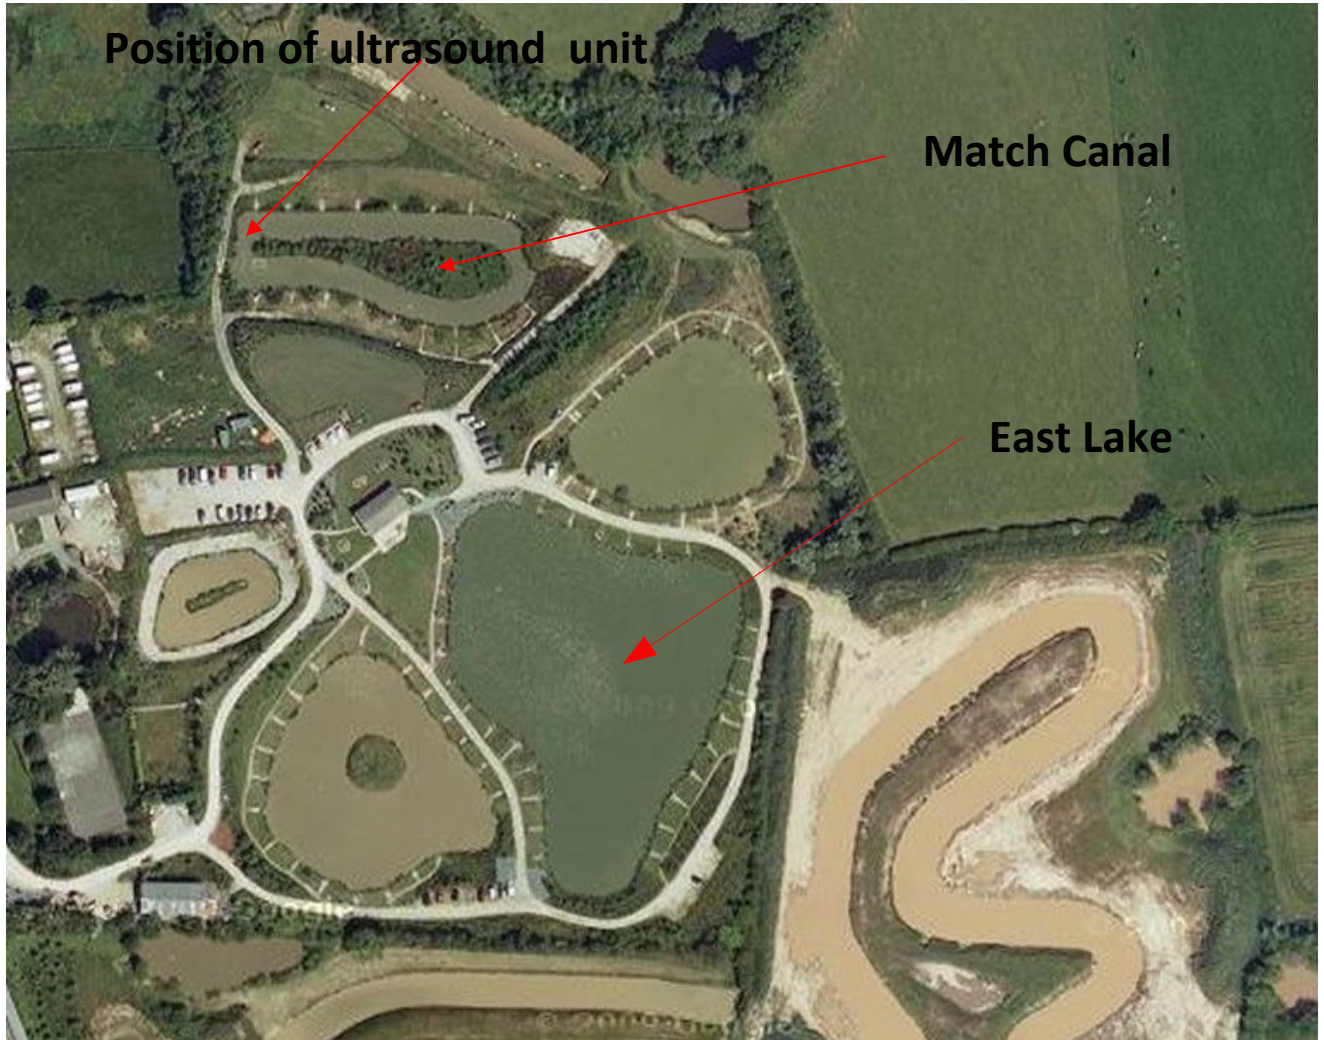
Whitmore Fisheries Layout

The East Lake was the primary source of the algal infestation. This lake overflows into the Match Canal. The presence of the blue-green algae is clearly visible in the East Lake and Match Canal even in this satellite photograph.

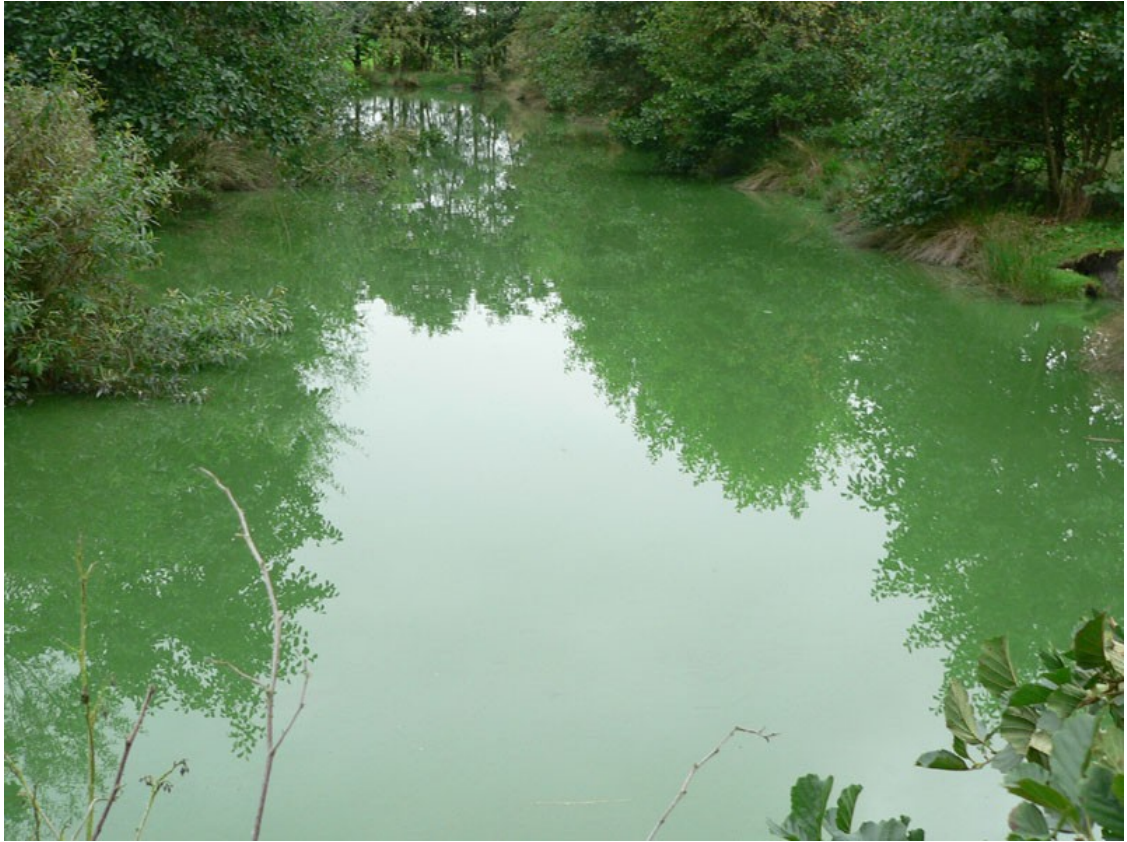
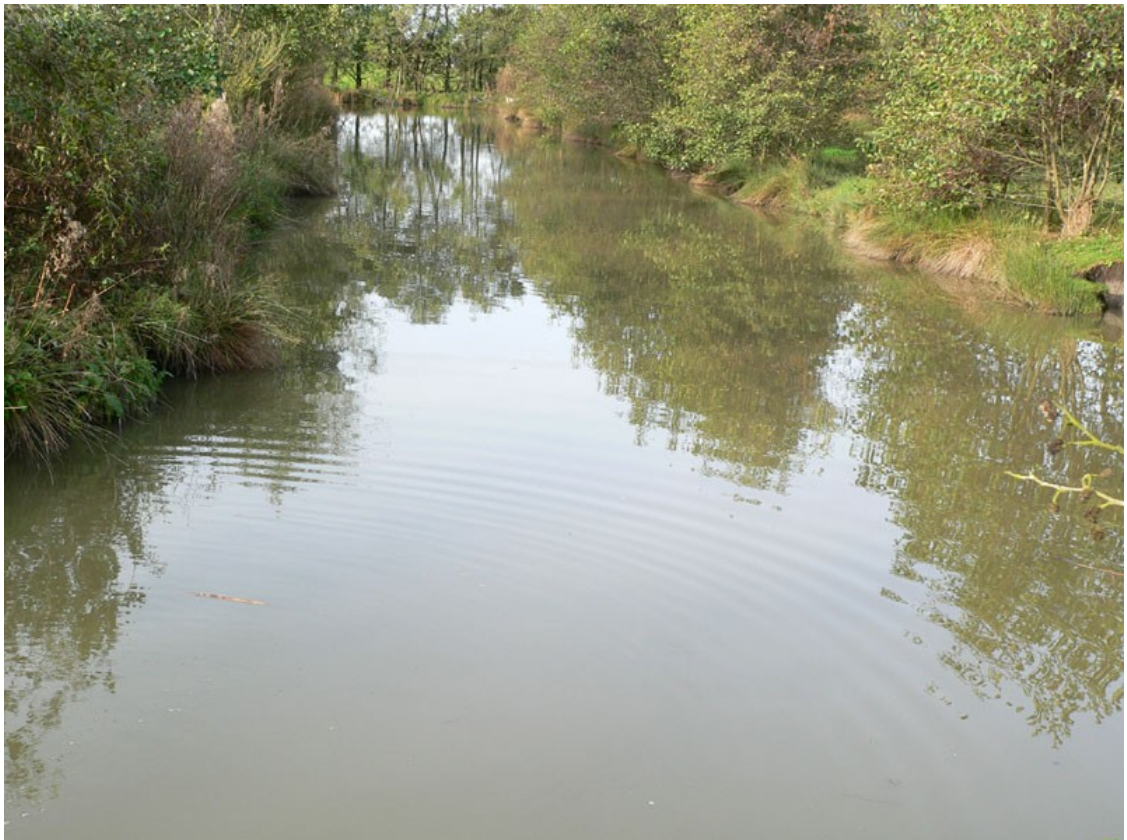
Looking towards Ultrasound unit. Above before – below after treatment

For the first 2 weeks of the trial, water from the also infected East Lake was over-flowing into this pool making the task difficult. Once this flow was halted, the *Oscillatoria* was eliminated within 10 days. Water temperature was not a contributing factor here, as the blue-green algae in the West Lake was still in abundance.

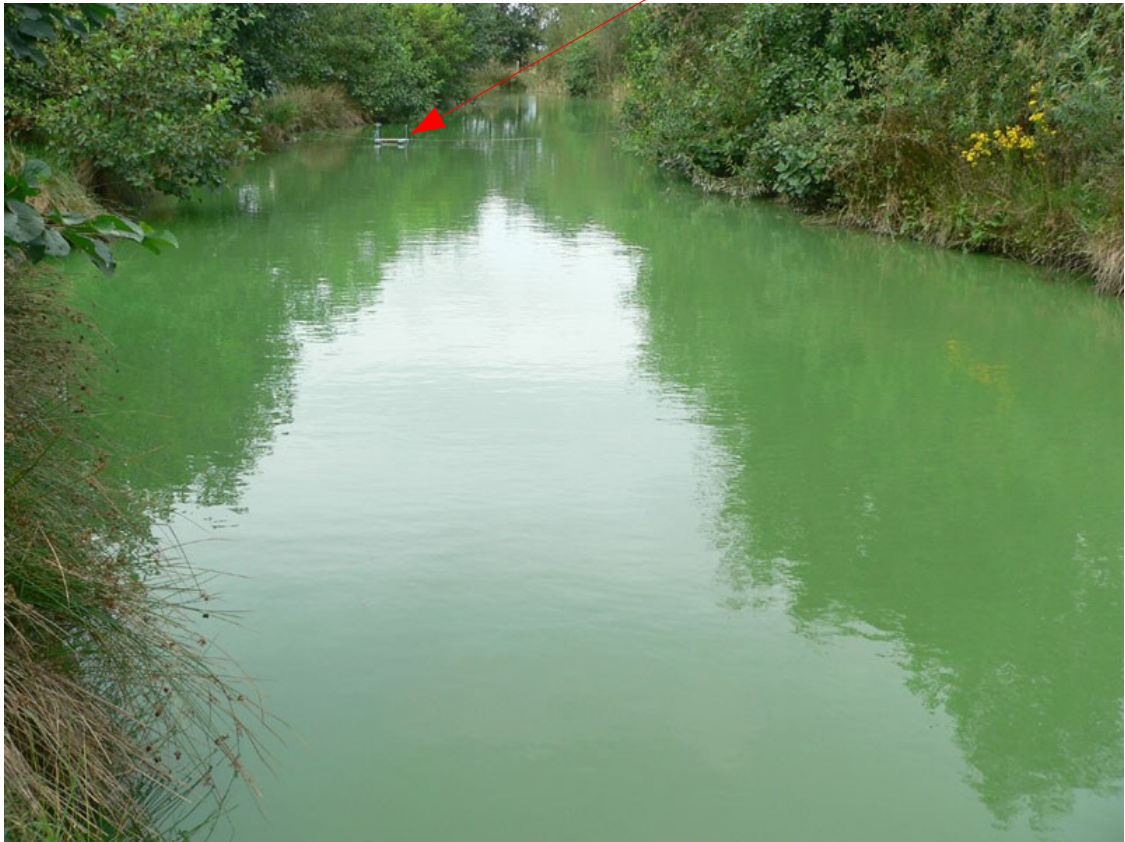
Aerator unit

In mid September 2010 a PondTec 50 ultrasound unit in the Match Canal. During the period of the trial, the pond was aerated using an aerator supplied by Aquaculture Equipment Ltd – this was an important requisite because as the blue-green algae was killed off, oxygen levels would drop with the potential for major fish kill. The results were very impressive.

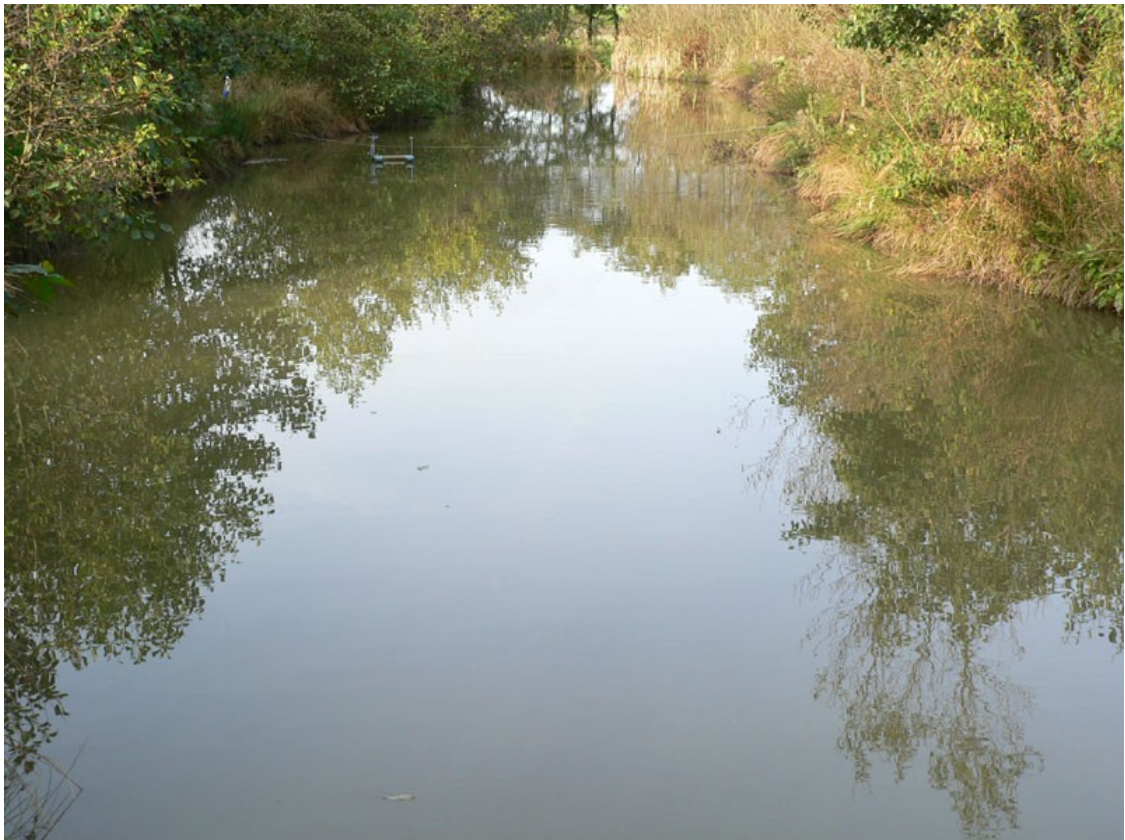
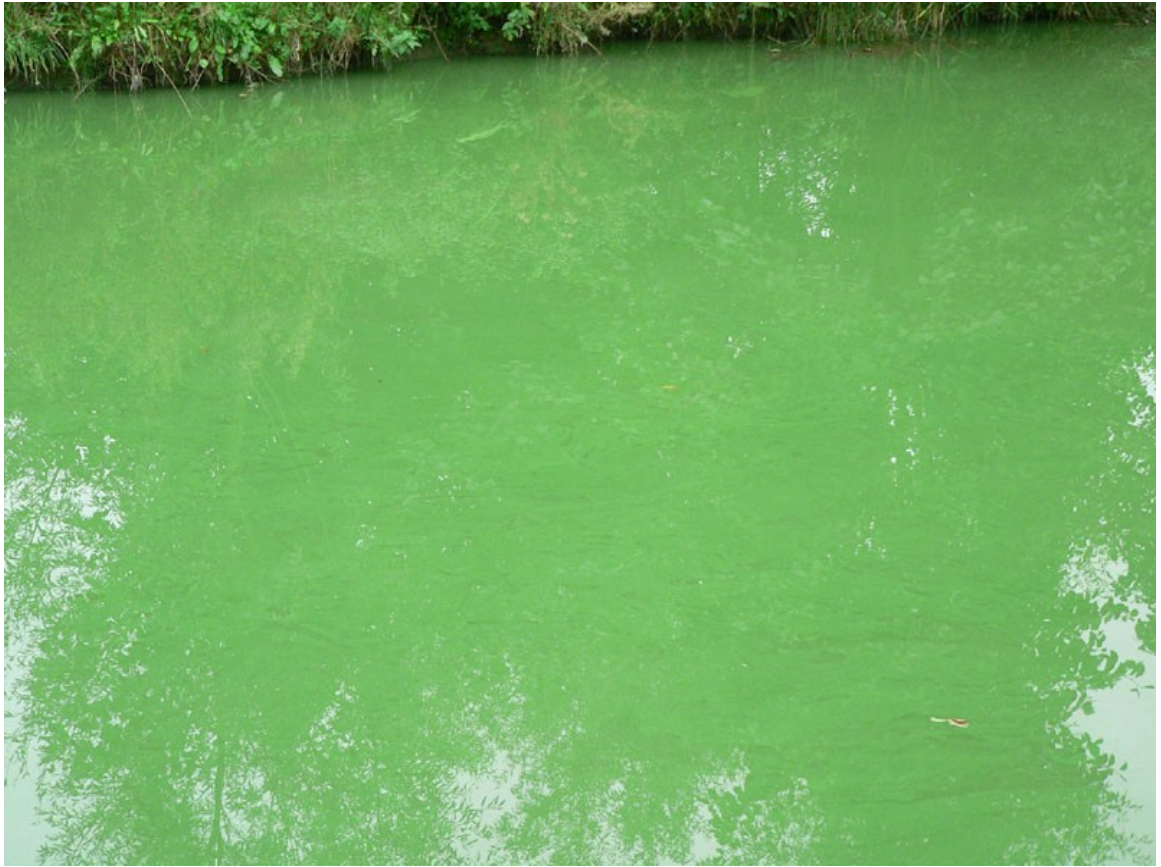
Other side of the pool. Above before – below after treatment

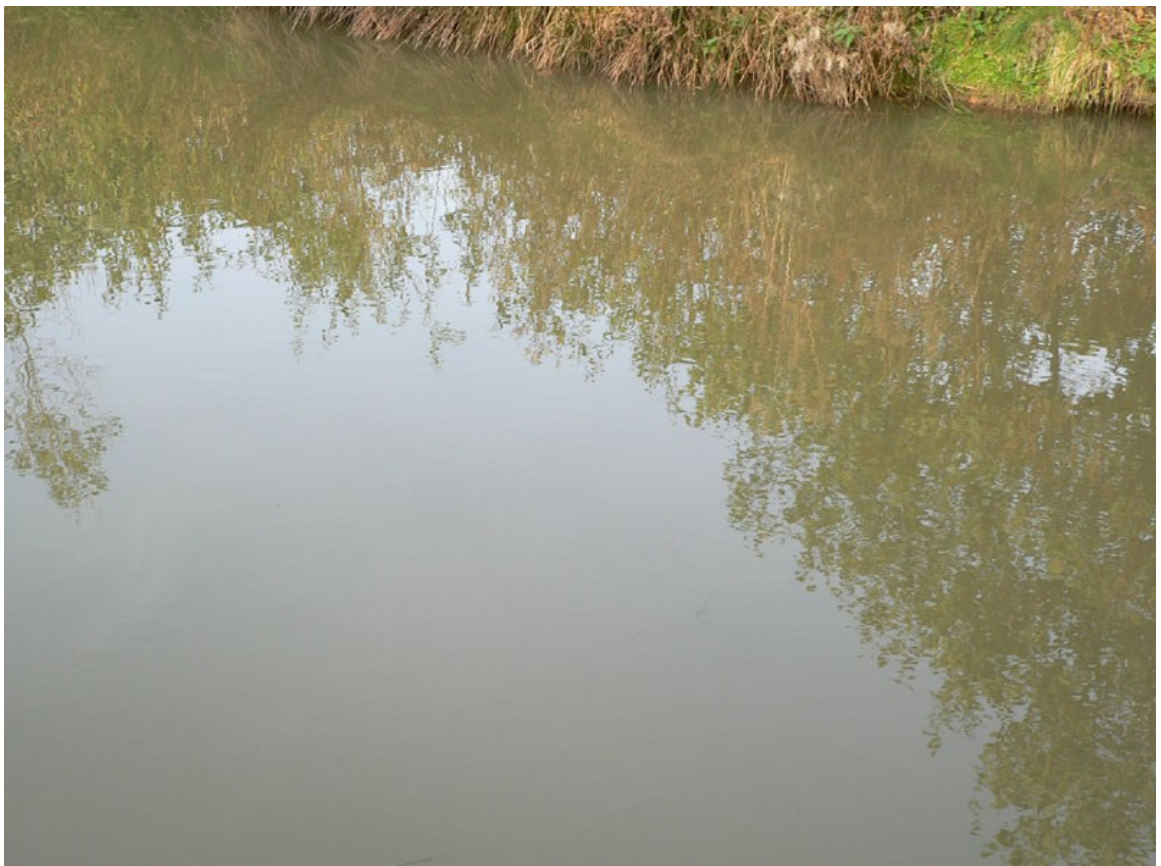
Close up of pool. Above before – below after treatment
